Pinholing

Pinholes as defined for this bulletin as very small holes that form in a waterproofing membrane or coating under certain conditions. The substrate most often associated with this phenomenon is concrete but it has also been observed in other porous substrate materials as well.

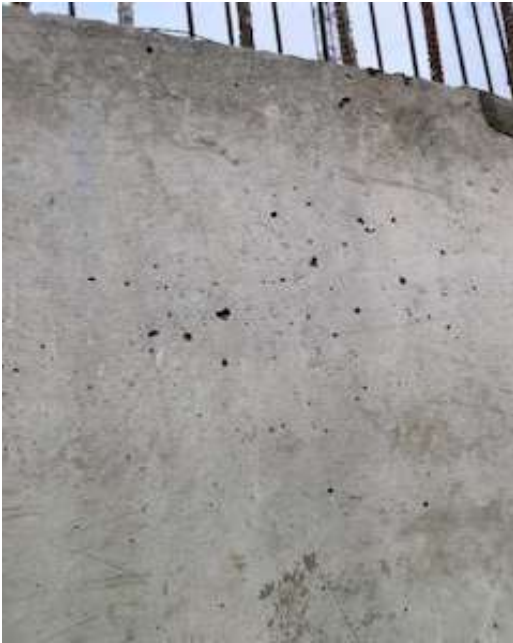
- Many times in concrete placements there are voids in the surface layer which are termed, “bug holes.” (Figures 1 and 2) These very small imperfections in the concrete can not be easily filled in with membrane or coating and air is typically trapped inside of them just below the membrane. As the concrete begins to heat up, the air/vapor molecules become excited, which in turn drives them upward seeking a less agitated state. As the molecules escape during this process, they penetrate through the wet uncured membrane or coating creating very small pinholes. (Figures 3 and 4)

Figure 1 - Bug holes

- High pressure water blast, shot blast, or sand blast to remove laitance and to open up bug holes to be properly addressed with an approved sealant or patching/repair mortar. If the substrate to be waterproofed is a wall and is in particularly poor condition a parge coat may be required.

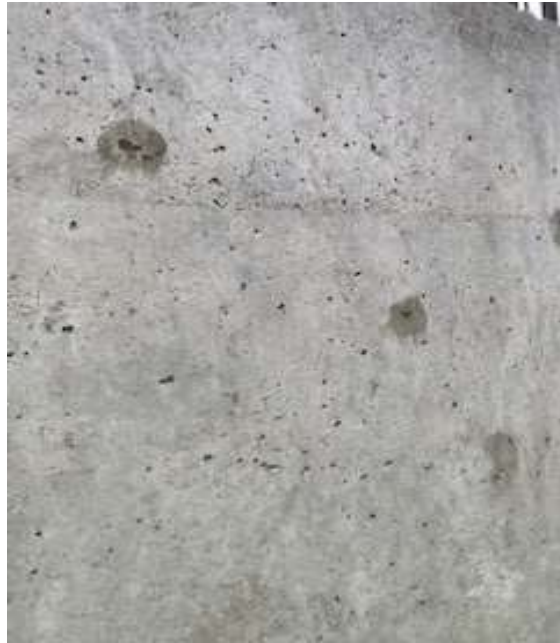
Figure 2 - Bug holes

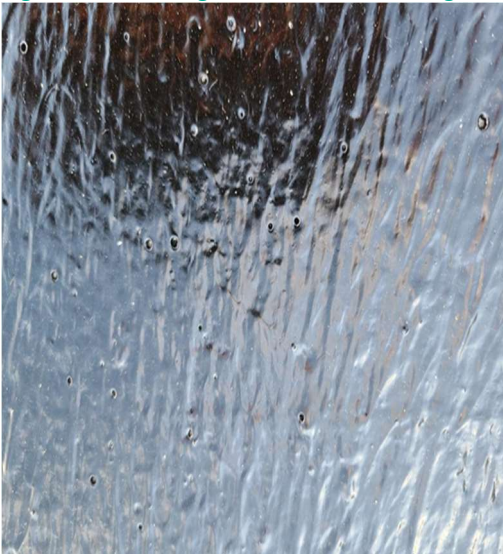
Figure 3 - Pinholing in a membrane during cure

- One of the simplest and most effective ways to minimize pinholing in membranes and coatings is to do the application when the substrate is cooling instead of heating. The work should commence during the late evening and overnight hours prior to sunrise.

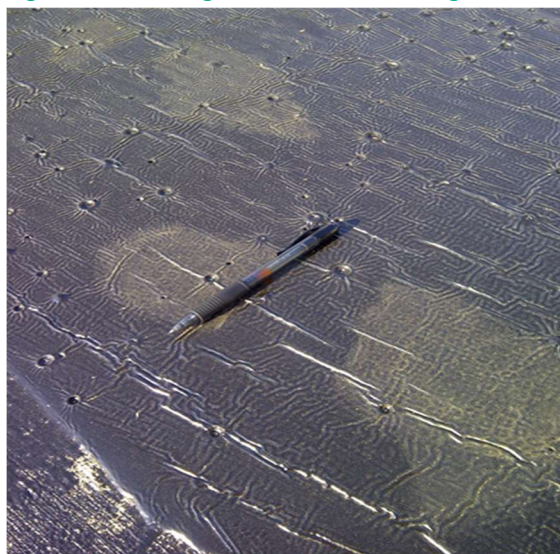
Figure 4 - Pinholing in a membrane during cure

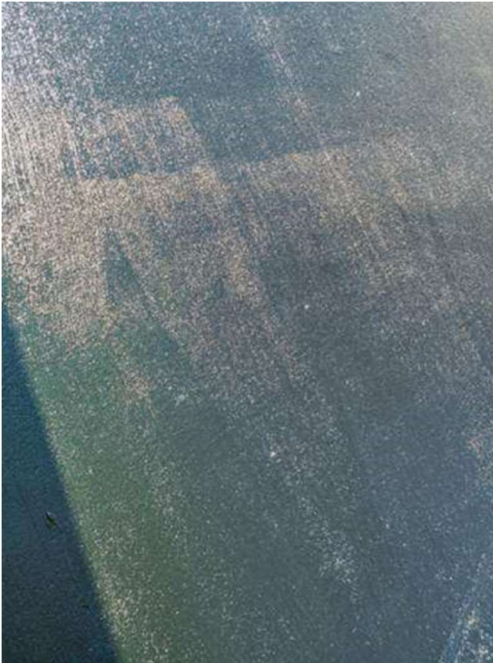
Figure 5 - Creating a membrane “scratch coat” with membrane

- Use the membrane in a thin film application to create what’s known as a scratch coat, by forcibly applying the product so that the membrane enters the small bug holes and capillaries of the concrete (figure 5). This filling action displaces the air/vapor trapped inside. Once the air/vapor present has been displaced the pinholing should be eliminated or greatly reduced.

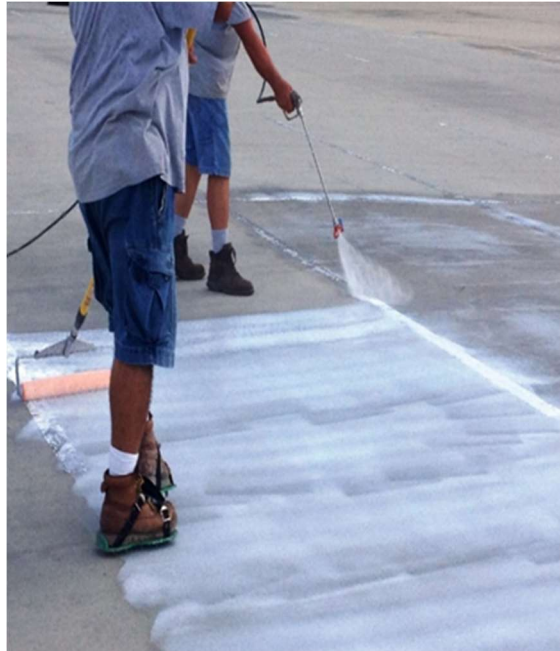
Figure 6 – Priming prior to membrane application to reduce or eliminate pinholing

- Use of a primer prior to the application of the membrane or coating. If moisture is present use of a moisture/vapor mitigating primer to lock down the substrate may be required. If the substrate is known to be dry or in a very low moisture state (Which should be confirmed via ASTM F 2170 Institu testing), other primers that are not considered to be moisture/vapor mitigating might be employed. (Figure 6)
